Formation and structure of composite coating of HDA and micro-plasma oxidation on A3 steel ^①

Abstract: Composite coatings were obtained on A3 steel by hot dipping aluminum(HDA) at 720 °C for 6 min and micro-plasma oxidation(MPO) in alkali electrolyte. The surface morphology, element distribution and interface structure of composite coatings were studied by means of XRD, SEM and EDS. The results show that the composite coatings obtained through HDA/MPO on A3 steel consist of four layers. From the surface to the substrate, the layer is loose Al₂O₃ ceramic, compact Al₂O₃ ceramic, Al and FeAl intermetallic compound layer in turn. The adhesions among all the layers are strengthened because the ceramic layer formed at the Al surface originally, FeAl intermetallic compound layer and substrate are combined in metallurgical form through mutual diffusion during HDA process. Initial experiment results disclose that the anti-corrosion performance and wear resistance of composite coating are obviously improved through HDA/MPO treatment.

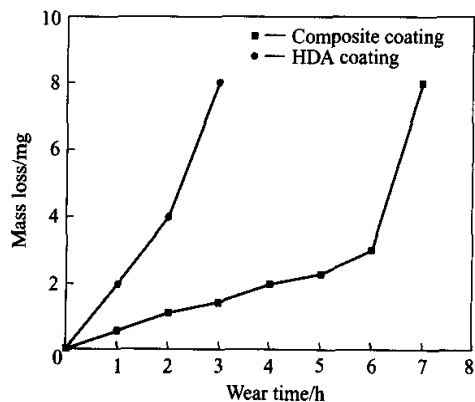
Mass loss results of composite coating are shown in Fig. 5. It can be seen that the mass loss of HDA coating decreases obviously after MPO treatment, that means its wear resistance is in-

Fig. 5 Curve of mass loss of coatings

creased. After a certain time during the testing, mass loss increases quickly, which is due to the exposition of the middle aluminum layer. So, the whole aluminum coating needs to be turned into ceramic layer to further improve the wear resistance of composite coating.
